# HASLEMERE TOWN COUNCIL

## Beacon Hill Recreation Ground – Playground Equipment Repairs

# Carousel - Rotators - Spica x 2

# Multiplay - Climber - Galaxy

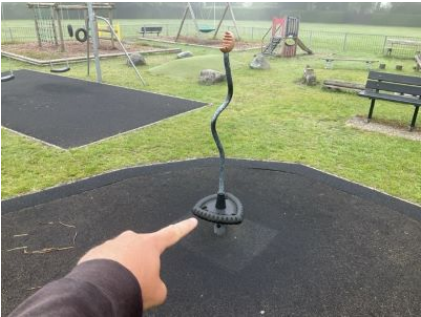
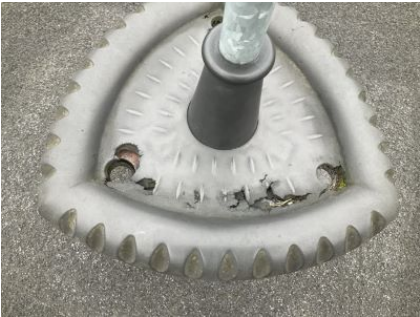
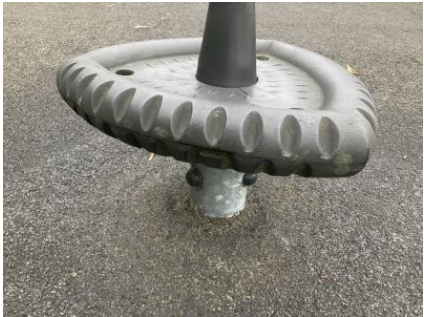
Item is damaged.

Orange top platform damaged leaving exposed metal frames to rust. Replace.  
Minor damage to yellow top platform rubbers. Monitor.

Medium

10

Replace., Read the notes for further action.

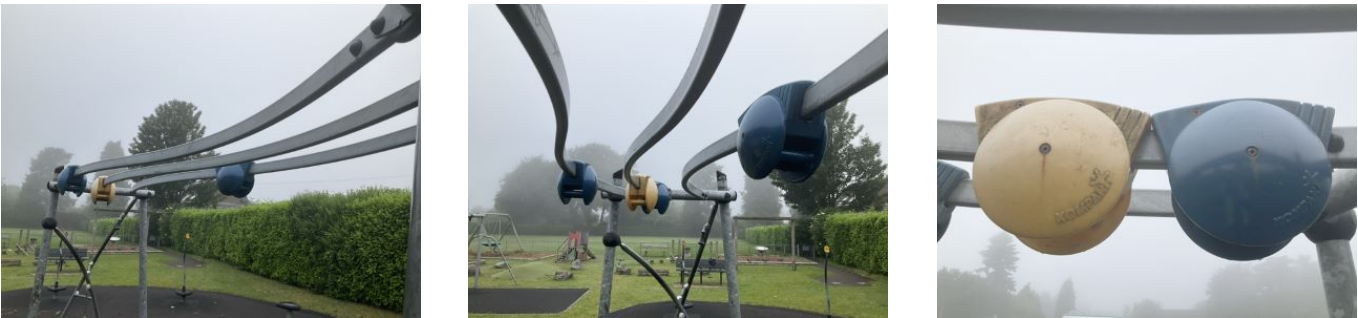
Overlapping of free spaces and / or falling spaces are not permitted.

Three overhead tracks in close proximity to each other.  
Two handholds on central track creates potential pinch/crush points between both hard plastics.

Medium

9

Refer to manufacturer for comment., Modify.

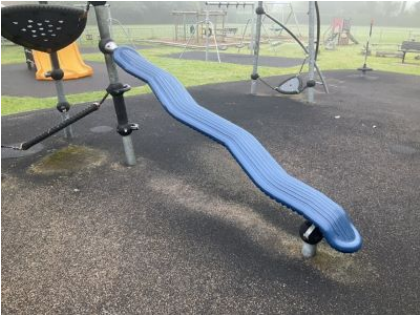
This item is associated with accidents. In RoSPA's opinion, this item may fail the requirements of EN 1176 (4.2.1) in that the movement of the blue climber on this unit is not apparent and foreseeable and could be considered to present a hazard to the user. Note that Kompan recommend making higher-installed units static, and they should be contacted for support.

Low

6

The unit was installed prior to the publication of the current standards. There is no requirement to make retrospective changes.

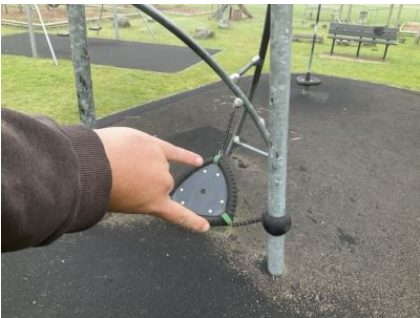
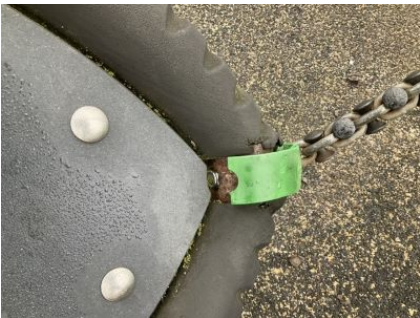
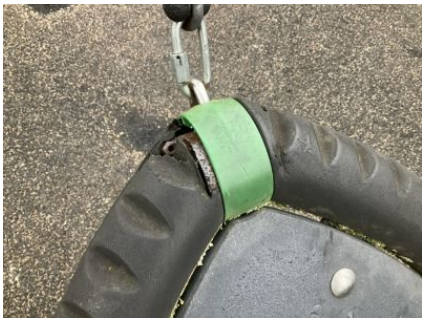
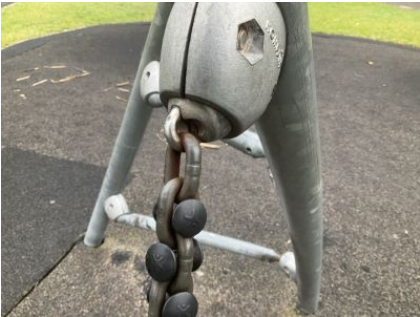
There is significant corrosion on this item.

Bottom highlighted platform. Replace entire section.  
Links worn through on bottom platform. Replace.

Medium

12

Immediately

Replace the item.

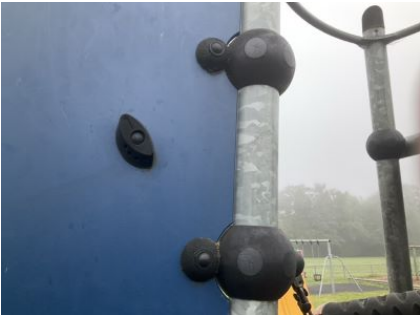
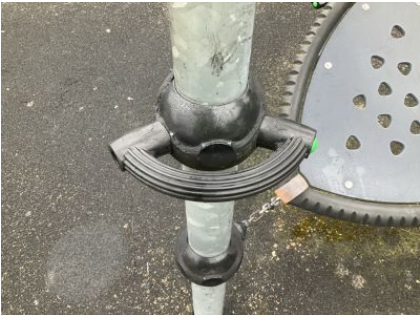
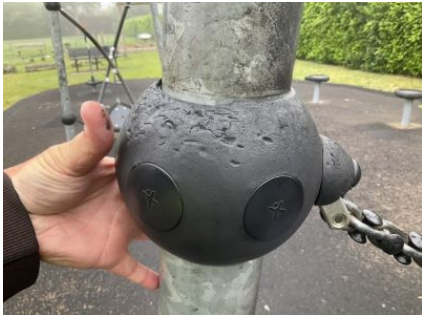
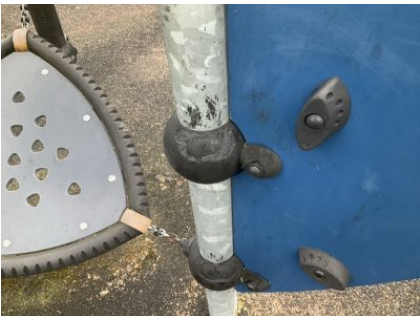
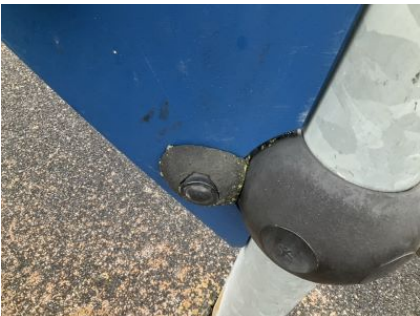
Surface is wearing.

Rubber surrounds on fixings. Wearing rubbers could stain clothes.

Medium

8

Monitor for significant deterioration and rectify when necessary., Replace.

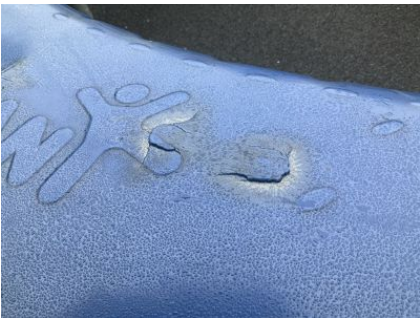
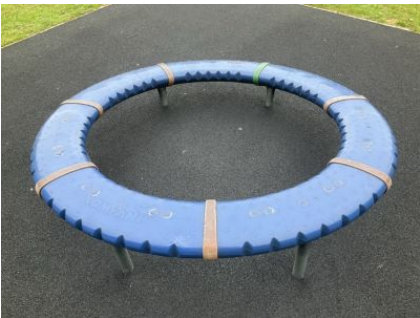
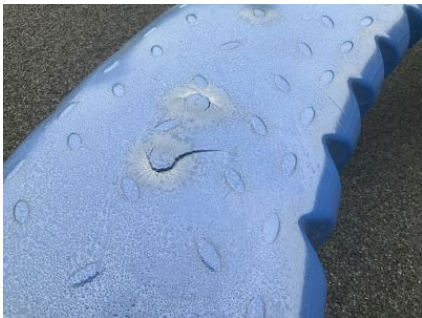
Item is damaged.

All sections of the carousel. Water ingress in frames due to this areas of damage on tops. Replace.  
Cracking throughout leaving sharp edges. Replace.

Medium

12

Replace.

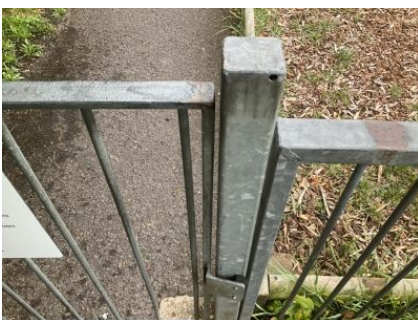
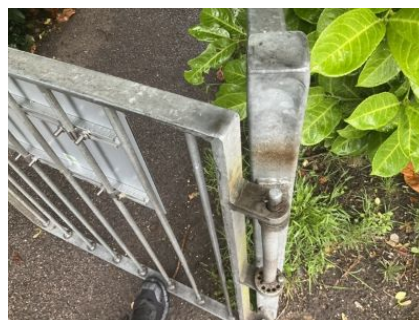
There is a crushing or shearing point on the side of the gate. Where the gaps reduce to less than 12 mm these have been known to cause serious, permanent injury to children, especially on the hinge side where the leverage forces are significant.

Adjust gate / posts / fit new rubber buffer to ensure a spacing of at least 12 mm throughout the range of the gate to remove the entrapment. The 12 mm gap also should apply on the hinge side of the gate.
