# HASLEMERE TOWN COUNCIL

## Beacon Hill Recreation Ground – Playground Equipment Repairs

# Carousel - Rotators - Spica x 2

# Multiplay - Climber - Galaxy

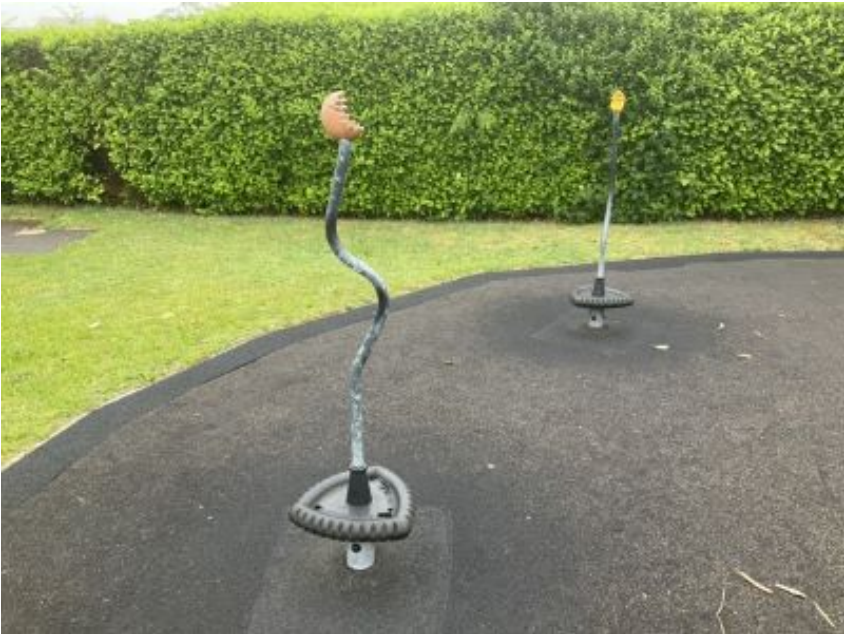
Item is damaged.

Orange top platform damaged leaving exposed metal frames to rust. Replace.  
Minor damage to yellow top platform rubbers. Monitor.

Replace., Read the notes for further action.

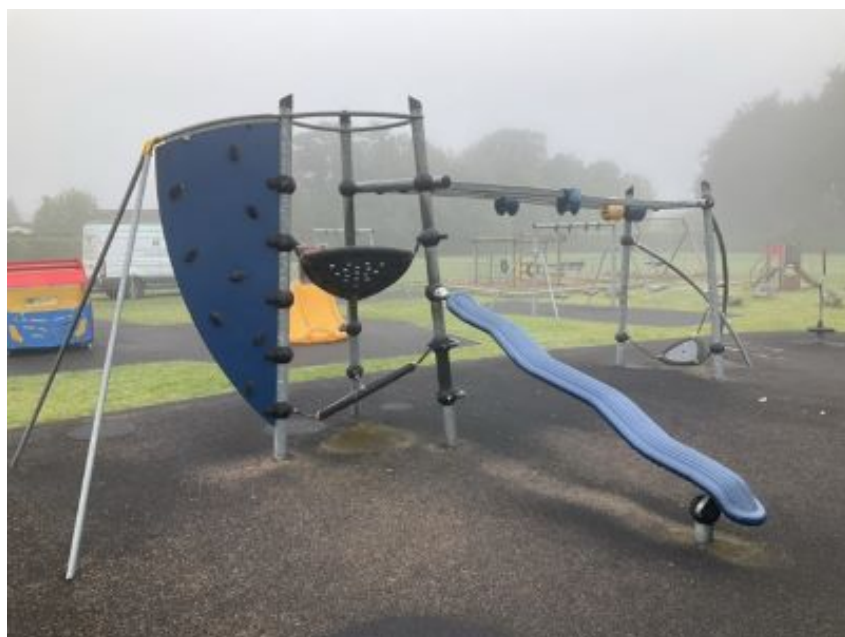
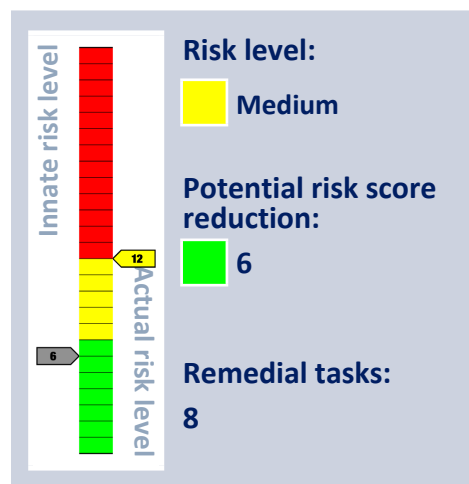
Neither the equipment nor the surfacing are compliant with the requirements of the relevant standards for the following reasons:

1. This item is associated with accidents. In RoSPA's opinion, this item may fail the requirements of EN 1176 (4.2.1) in that the movement of the blue climber on this unit is not apparent and foreseeable and could be considered to present a hazard to the user. Note that Kompan recommend making higher-installed units static, and they should be contacted for support.

1. Overlapping of free spaces and / or falling spaces are not permitted.

1. There is significant corrosion on this item.
2. Surface is wearing.
3. Fixtures loose or missing.
4. Item has some parts missing.

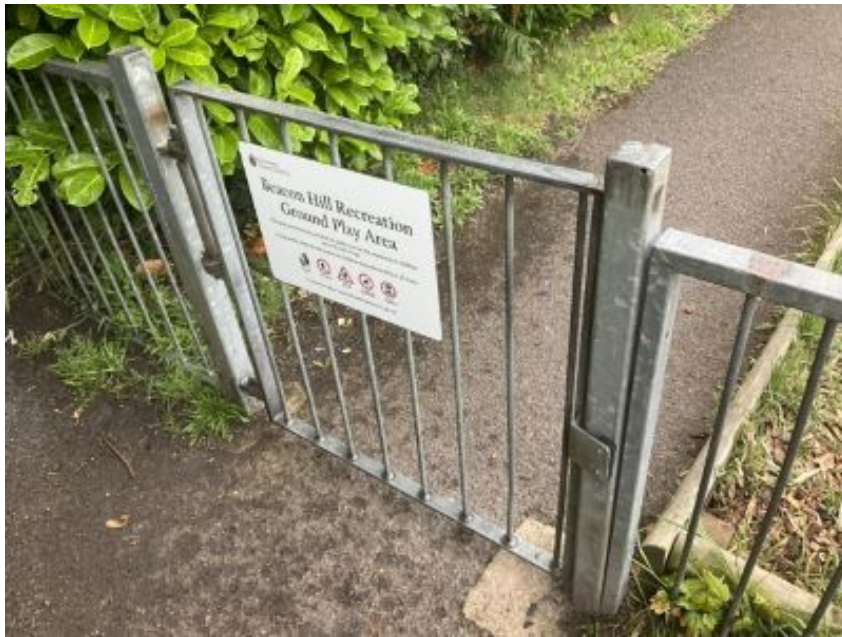
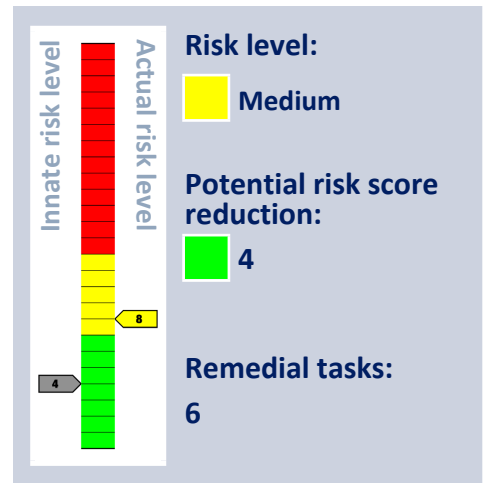
There is a crushing or shearing point on the side of the gate. Where the gaps reduce to less than 12 mm these have been known to cause serious, permanent injury to children, especially on the hinge side where the leverage forces are significant.
